OSOYOOS LAKE WATER QUALITY SOCIETY

WATER TESTING 2017

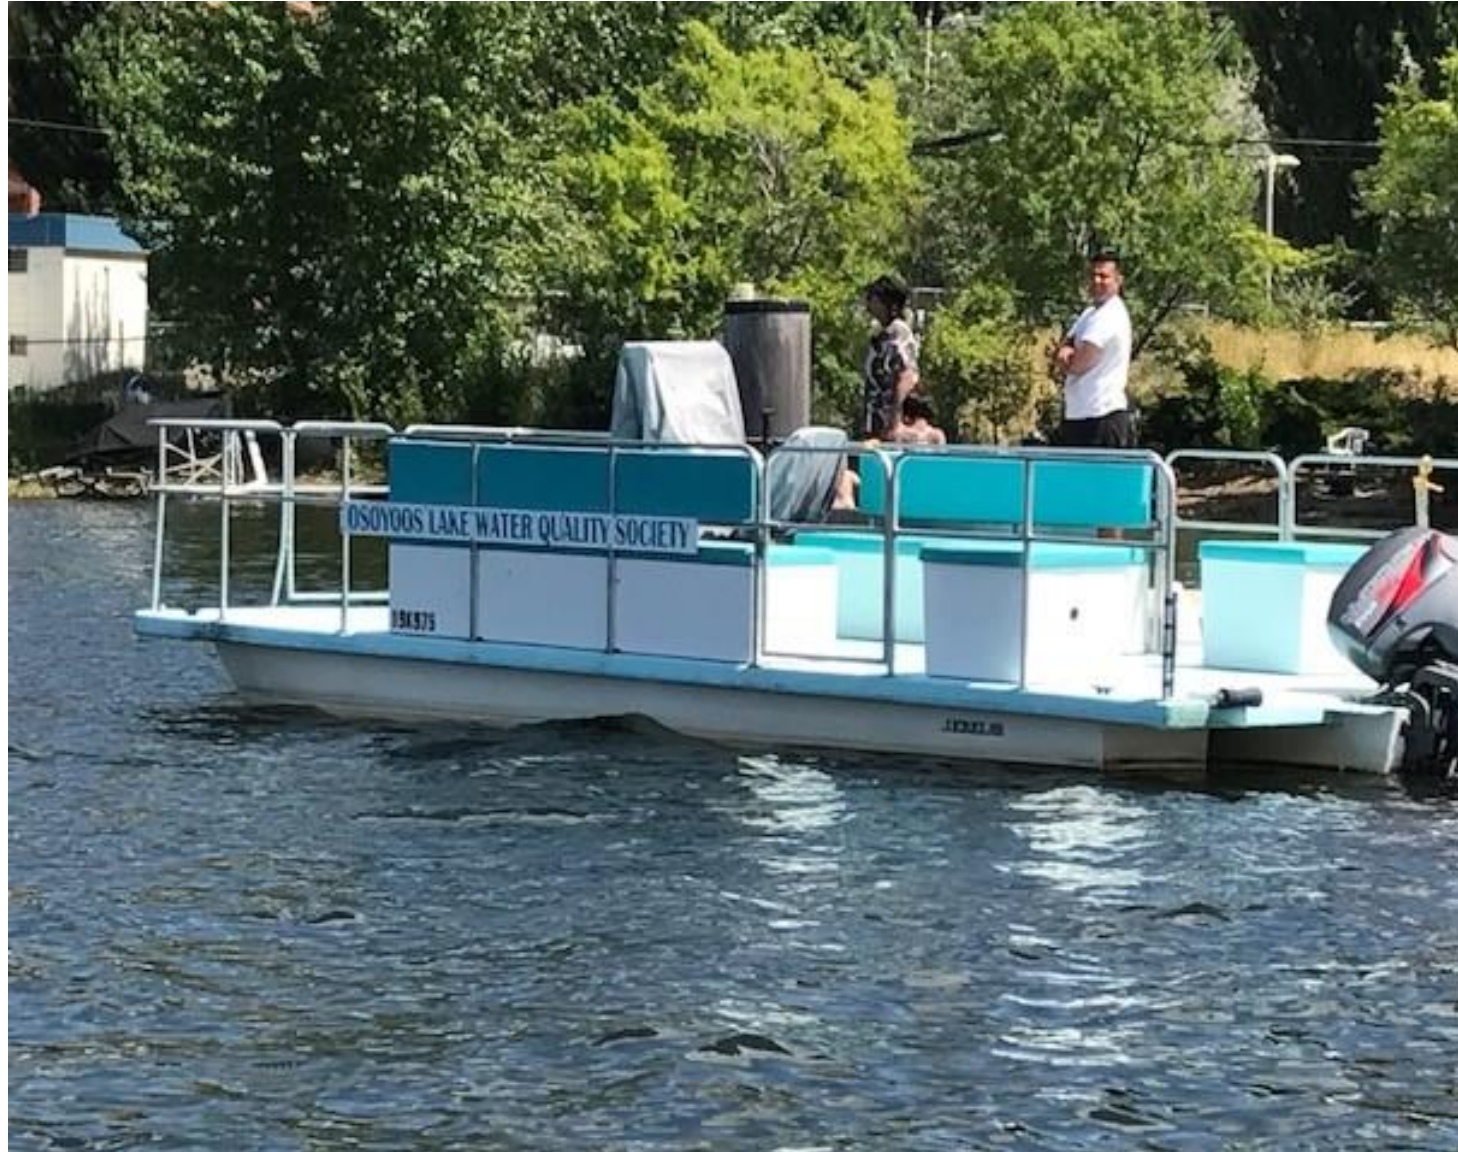
PONTOON BOAT, USED FOR WATER TESTING AT THE FIVE LOCATIONS

About the pontoon boat:

- Owned by OLWQS.
- Flat and low deck, good for water testing.
- Low profile, goes under bridge during summer.
- 50 HP 4-stroke outboard motor.

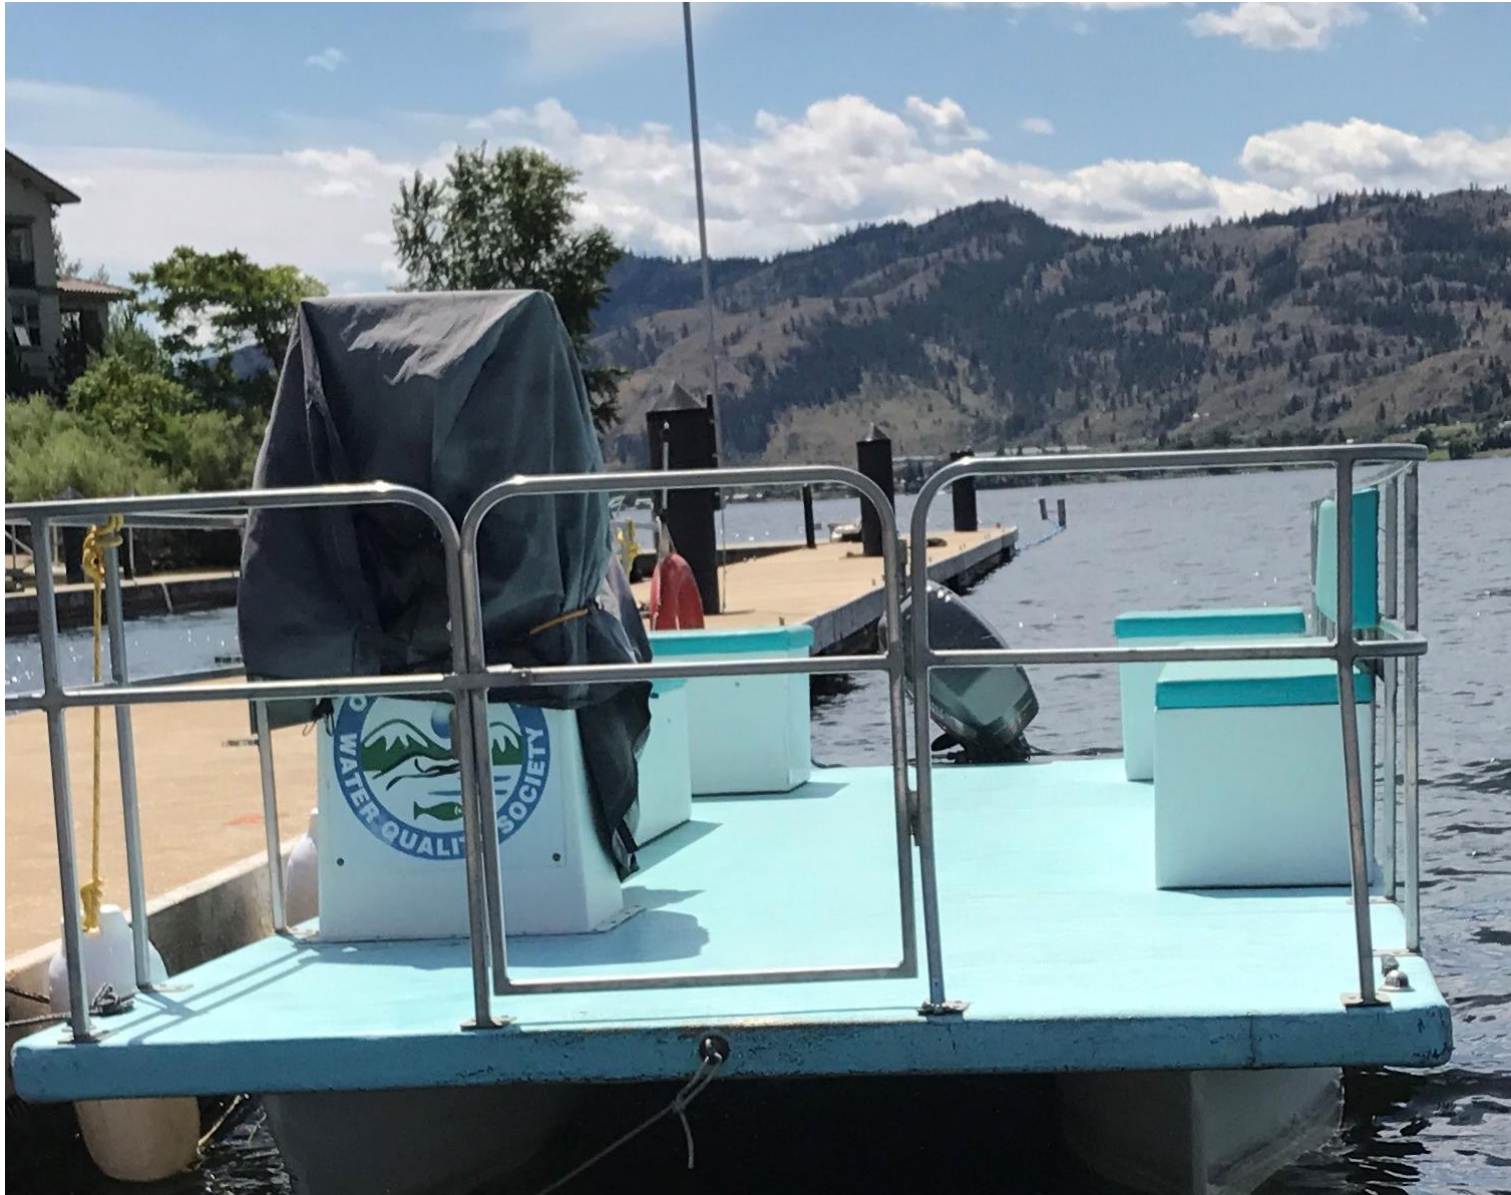
PONTOON BOAT, USED FOR WATER TESTING AT THE FIVE LOCATIONS

More about the pontoon boat:

- Purchased year 2003, new.

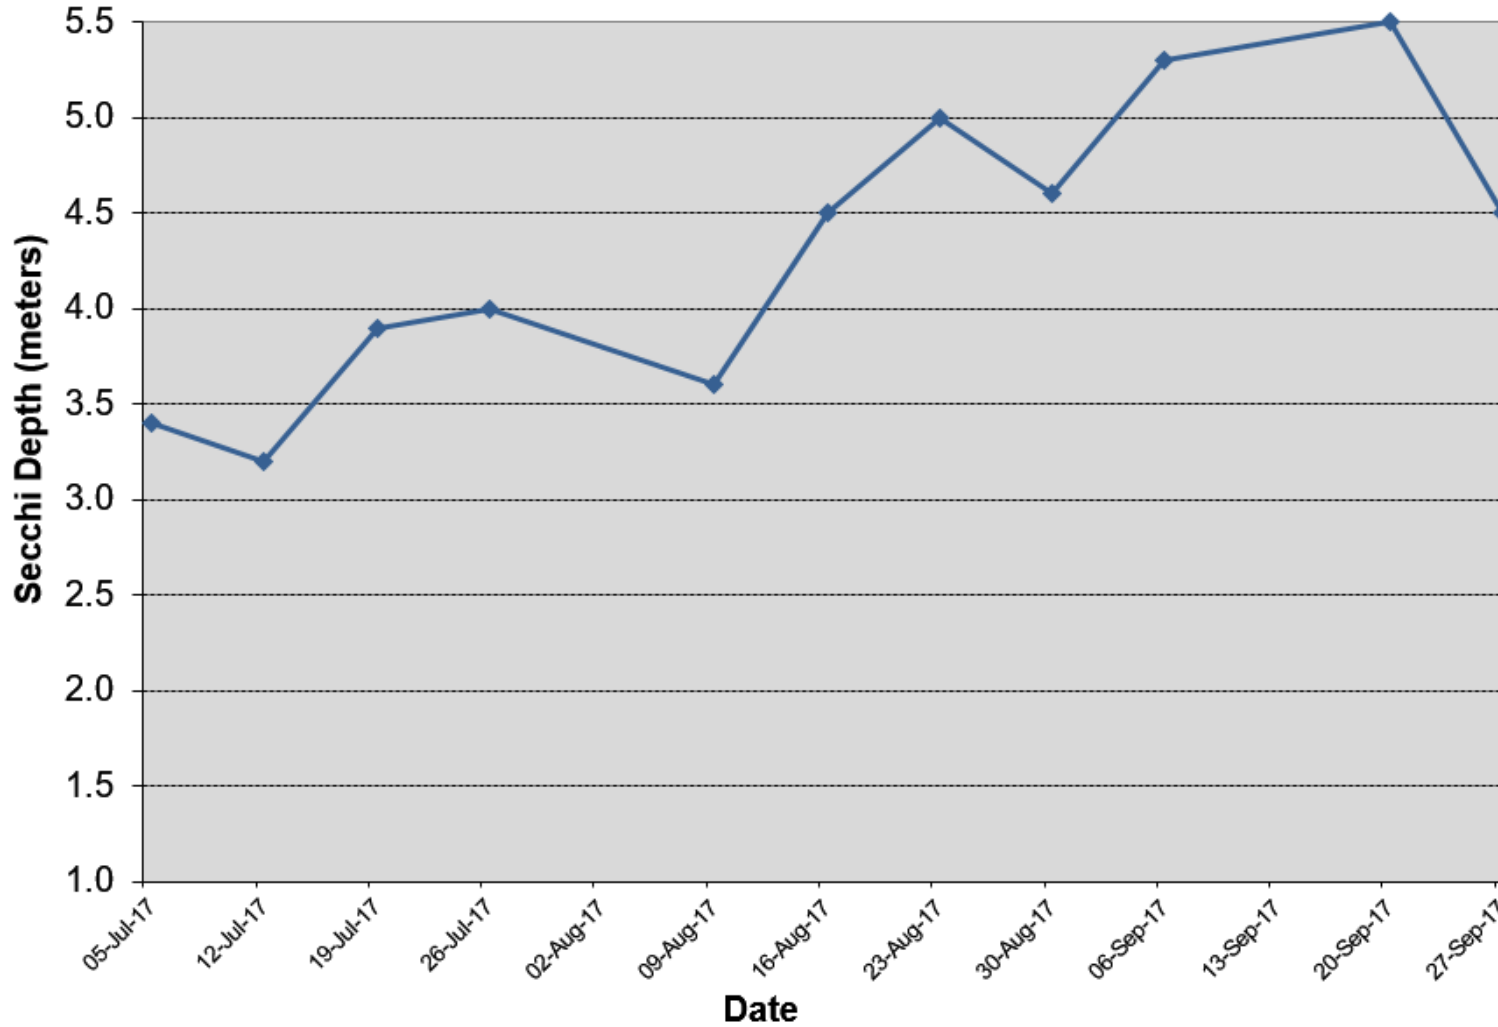
EXAMPLE OF SECCHI CHART

Osoyoos Lake at Packing house - Secchi Depth 2017

Objective value: $\geq 3.5\text{m}$,
seasonal mean May to
September.

Objective source: MoE report
'OsoyoosWQOFinal_1 ---'

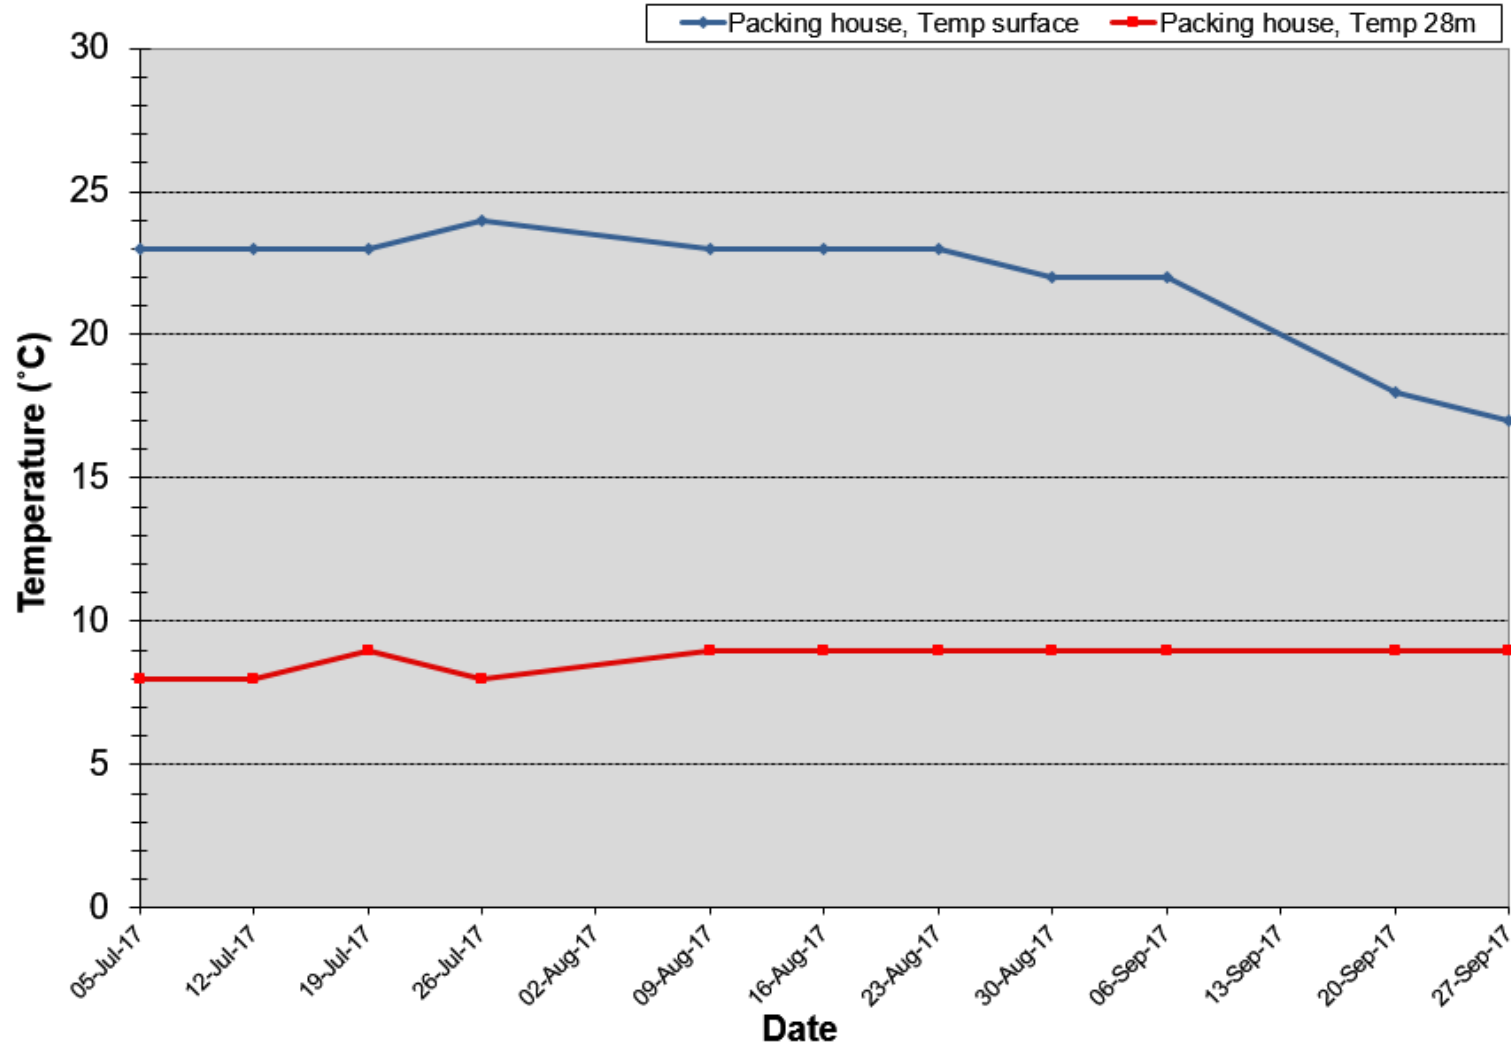
EXAMPLE OF SURFACE AND BOTTOM TEMPERATURE CHART

Osoyoos Lake at Packing house - Water Temperature 2017

Objective value: None

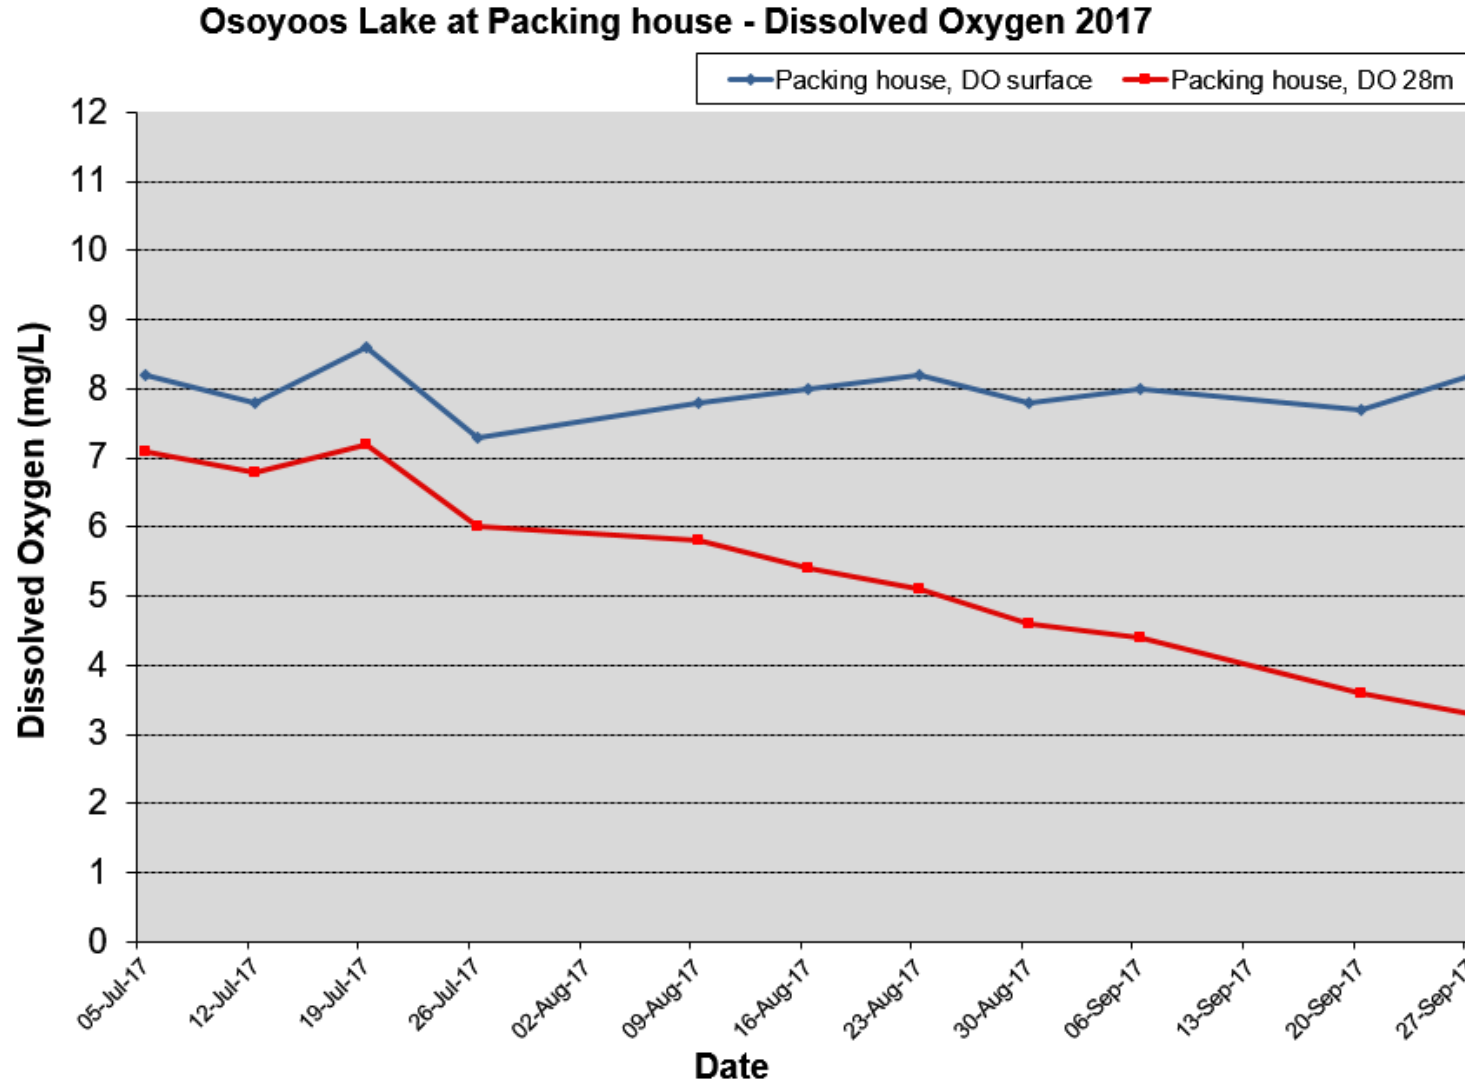
EXAMPLE OF SURFACE AND BOTTOM DISSOLVED OXYGEN CHART

Objective value: None for surface and 24m.

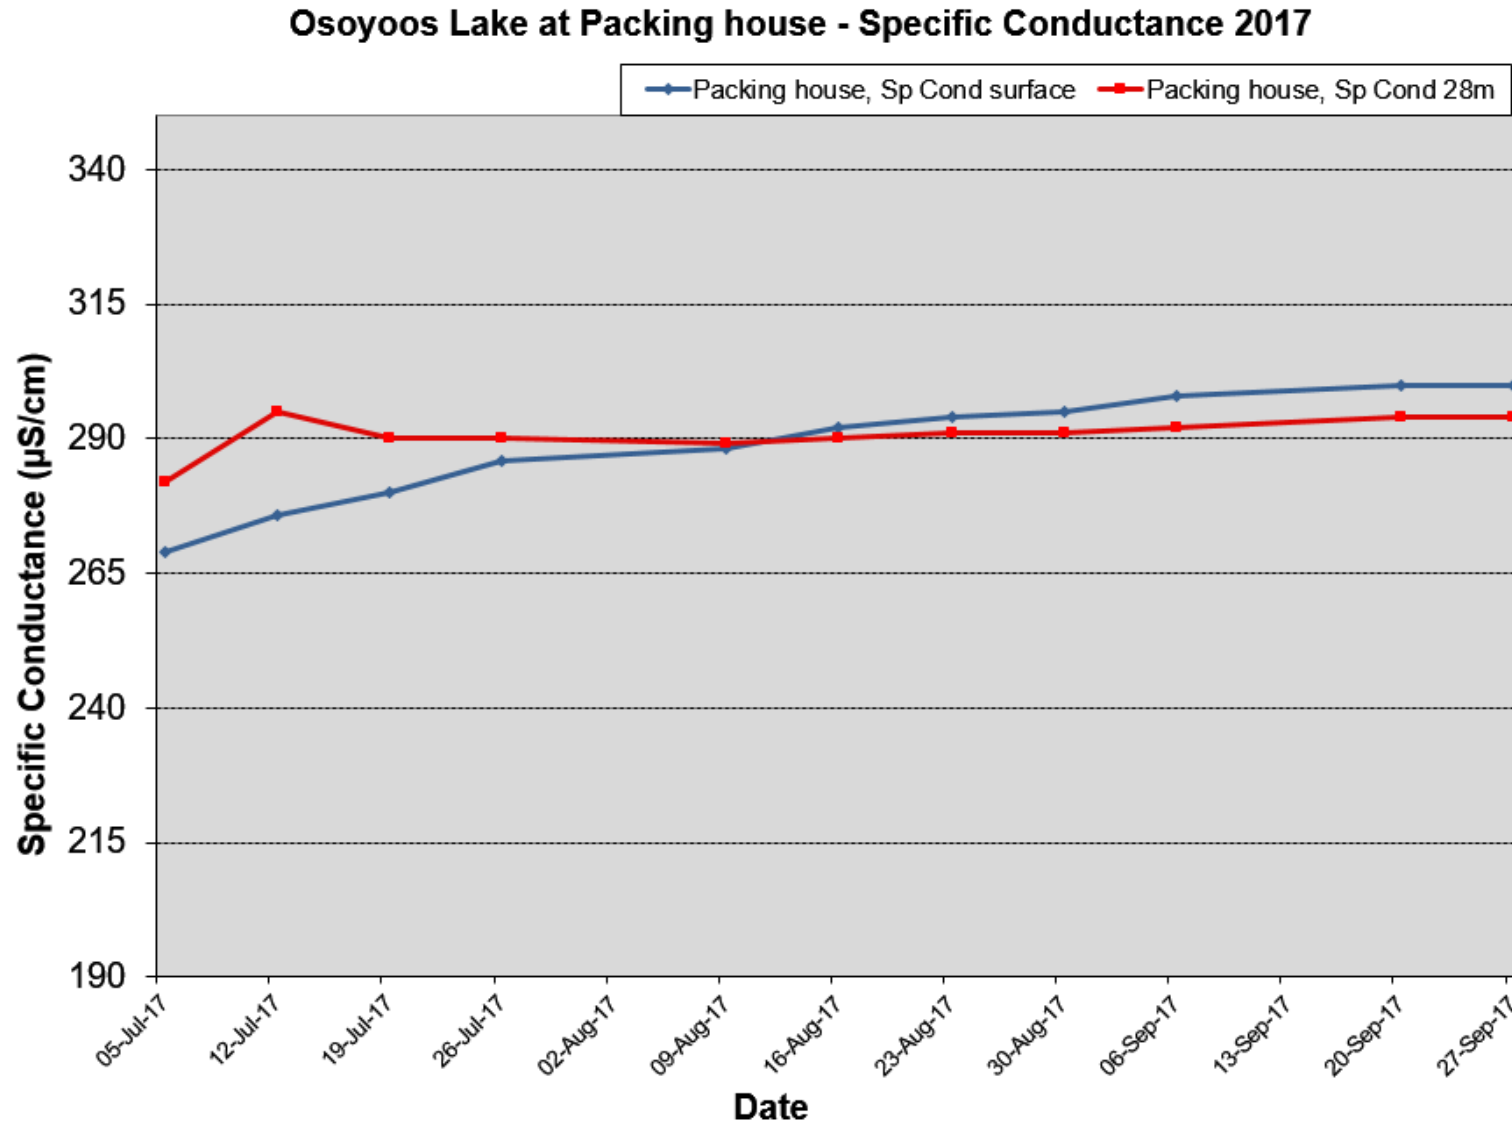
EXAMPLE OF SURFACE AND BOTTOM SPECIFIC CONDUCTIVITY (25 C) CHART

Objective value: None.

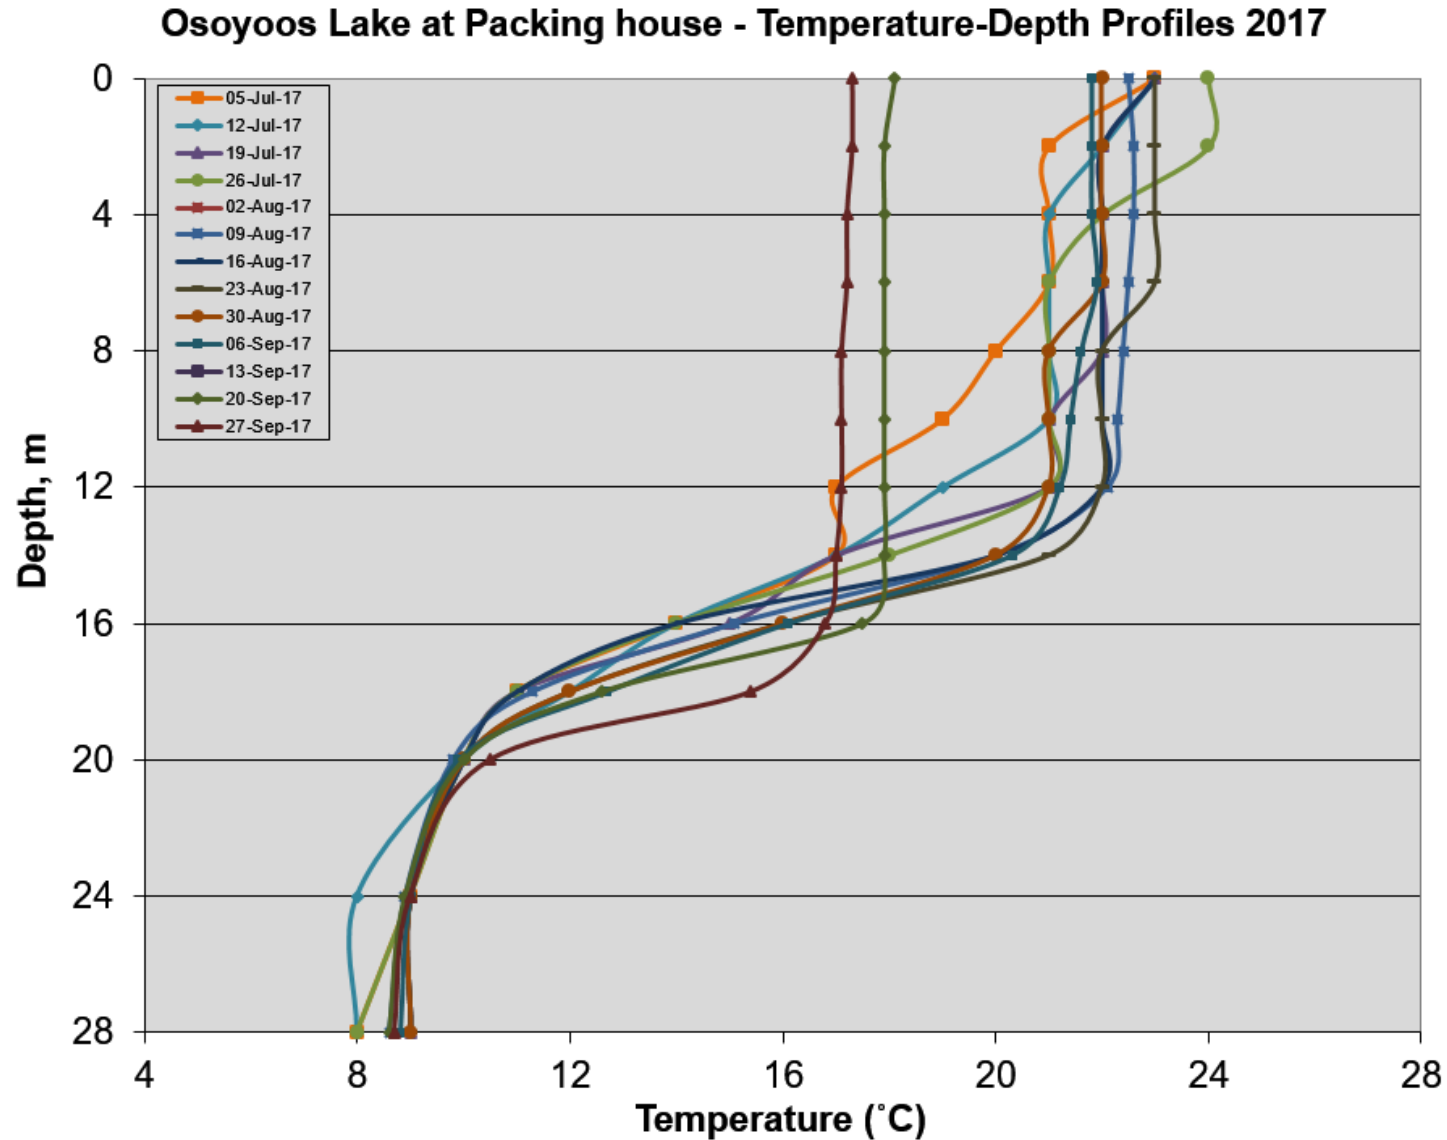
EXAMPLE OF TEMPERATURE-DEPTH PROFILE CHART

Objective value: None.

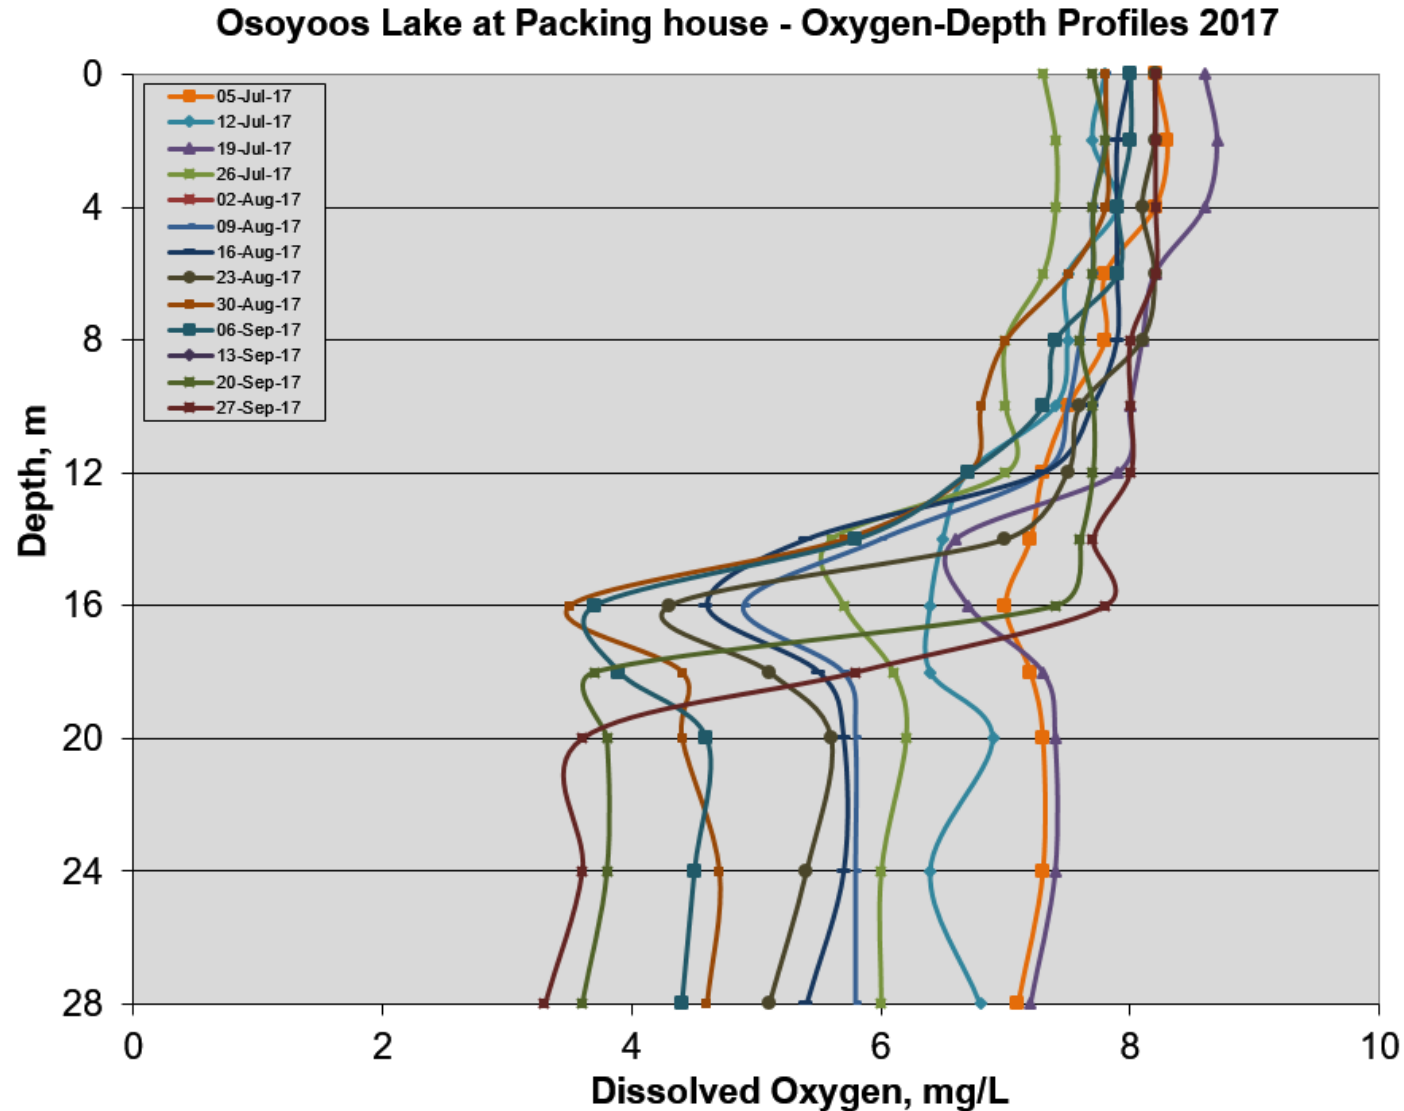
EXAMPLE OF DISSOLVED OXYGEN-DEPTH PROFILE CHART

Objective value: ≥ 5.8 mg/L at 15m on August 15th.

Objective source: MoE report 'OsoyoosWQOFinal_1 ---'

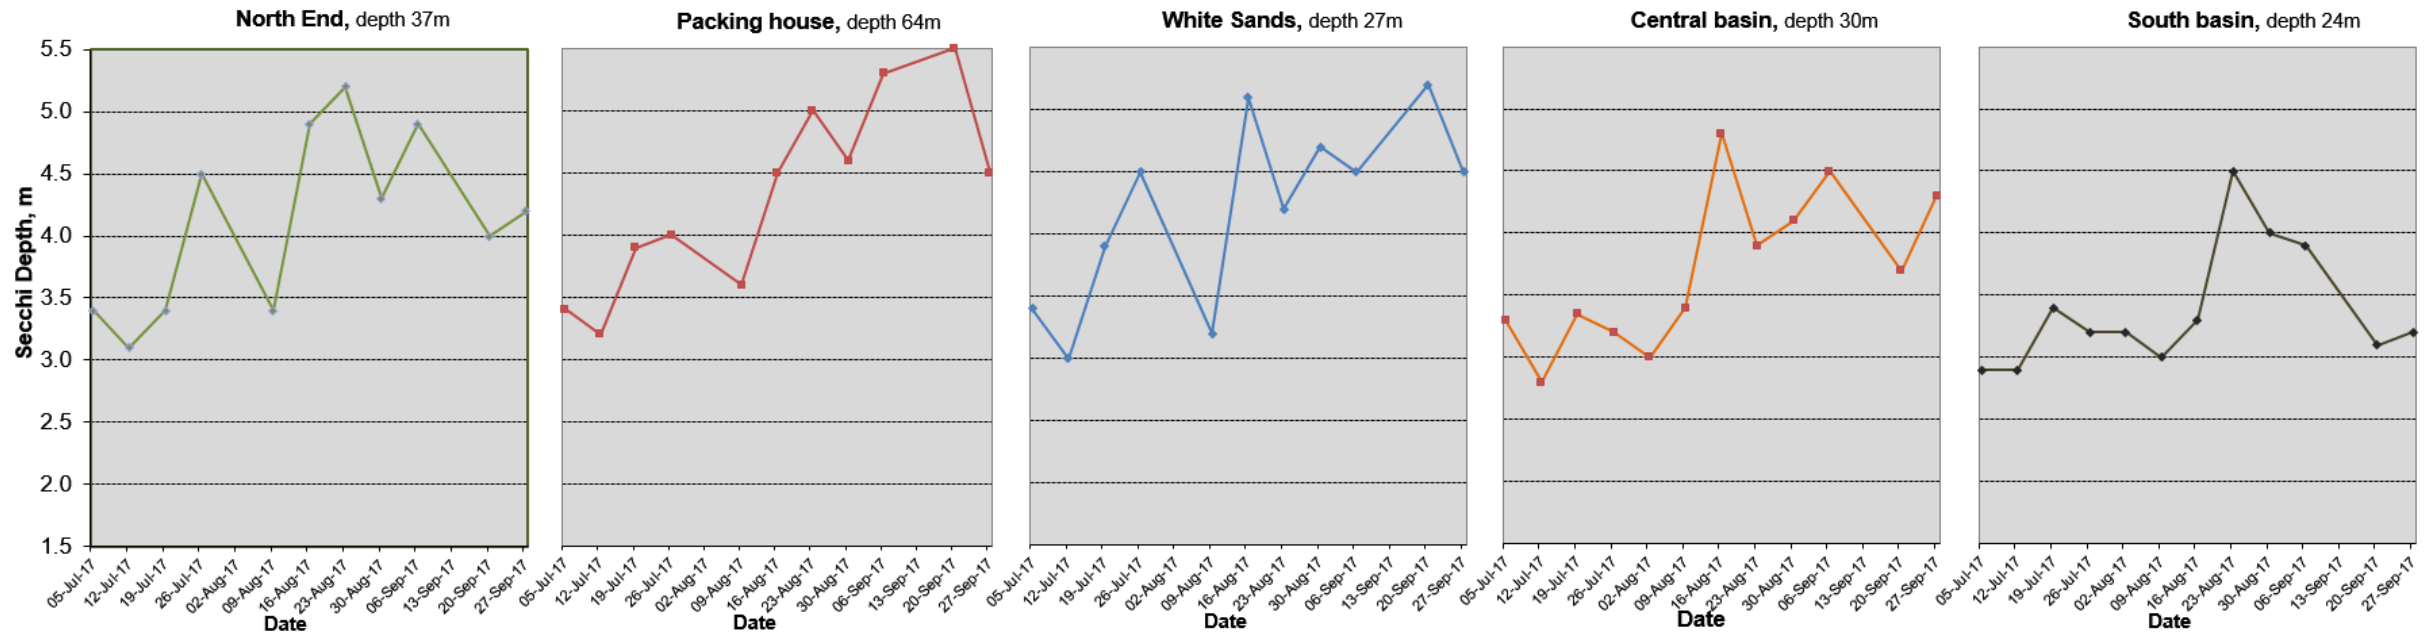
COMPARISON CHARTS 2017 - SECCHI DEPTH, NORTH END TO SOUTH BASIN IN THE DIRECTION OF WATER FLOW

OBJECTIVE VALUE: ≥ 3.5 m mean, May to September.

OBSERVATION: A trend towards the South basin having lowest Secchi depths, or highest turbidity.

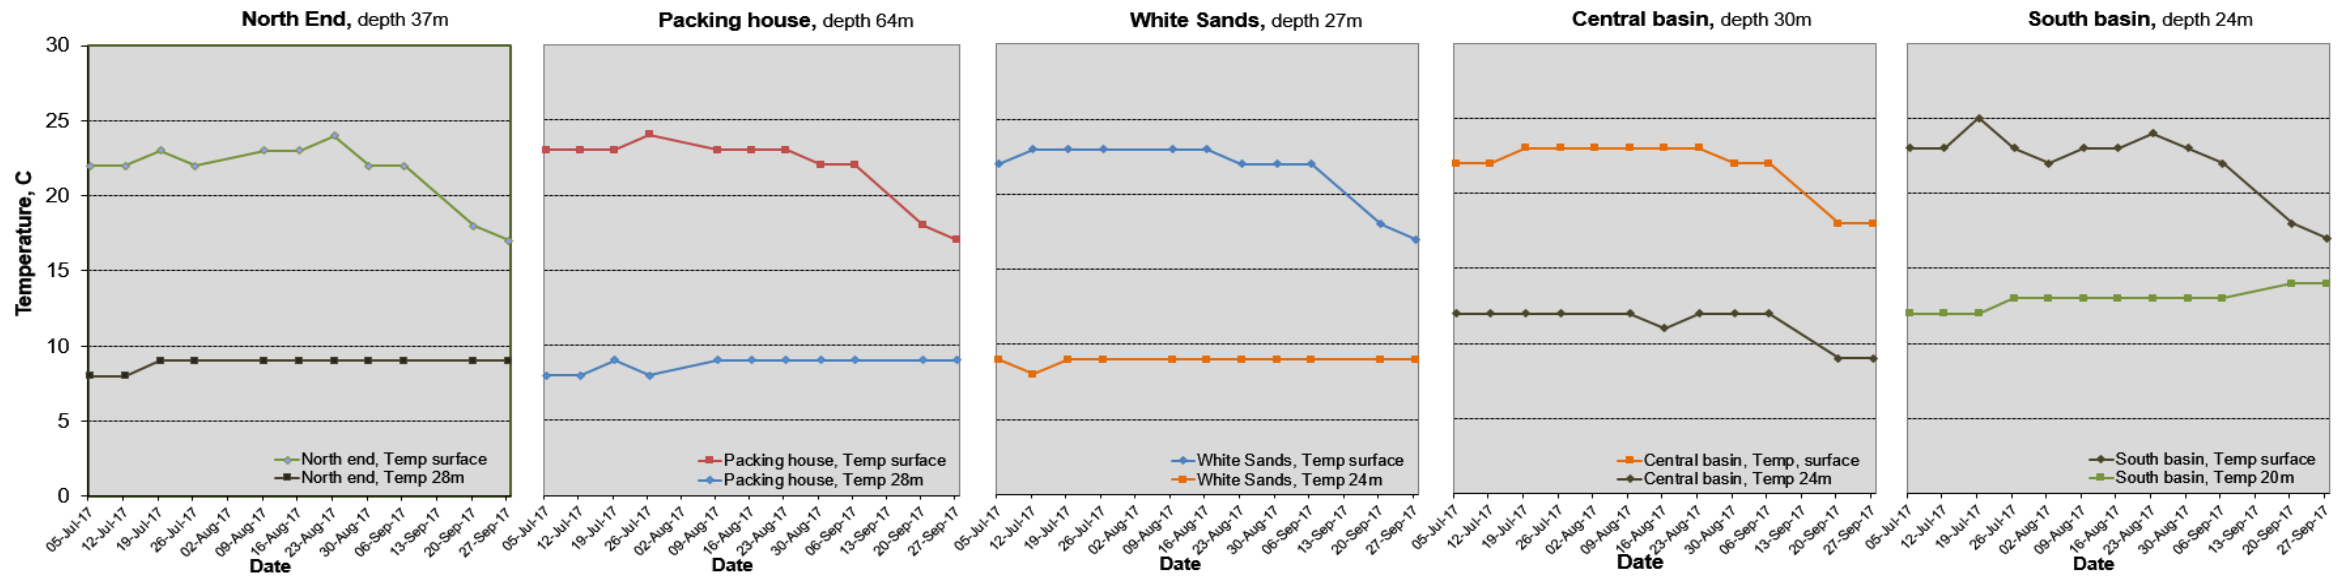
COMPARISON CHARTS 2017 - TOP AND BOTTOM TEMPERATURES, NORTH END TO SOUTH BASIN IN THE DIRECTION OF WATER FLOW.

OBJECTIVE VALUE: None.

OBSERVATION: Steady cold bottom temperatures for the North basin locations.

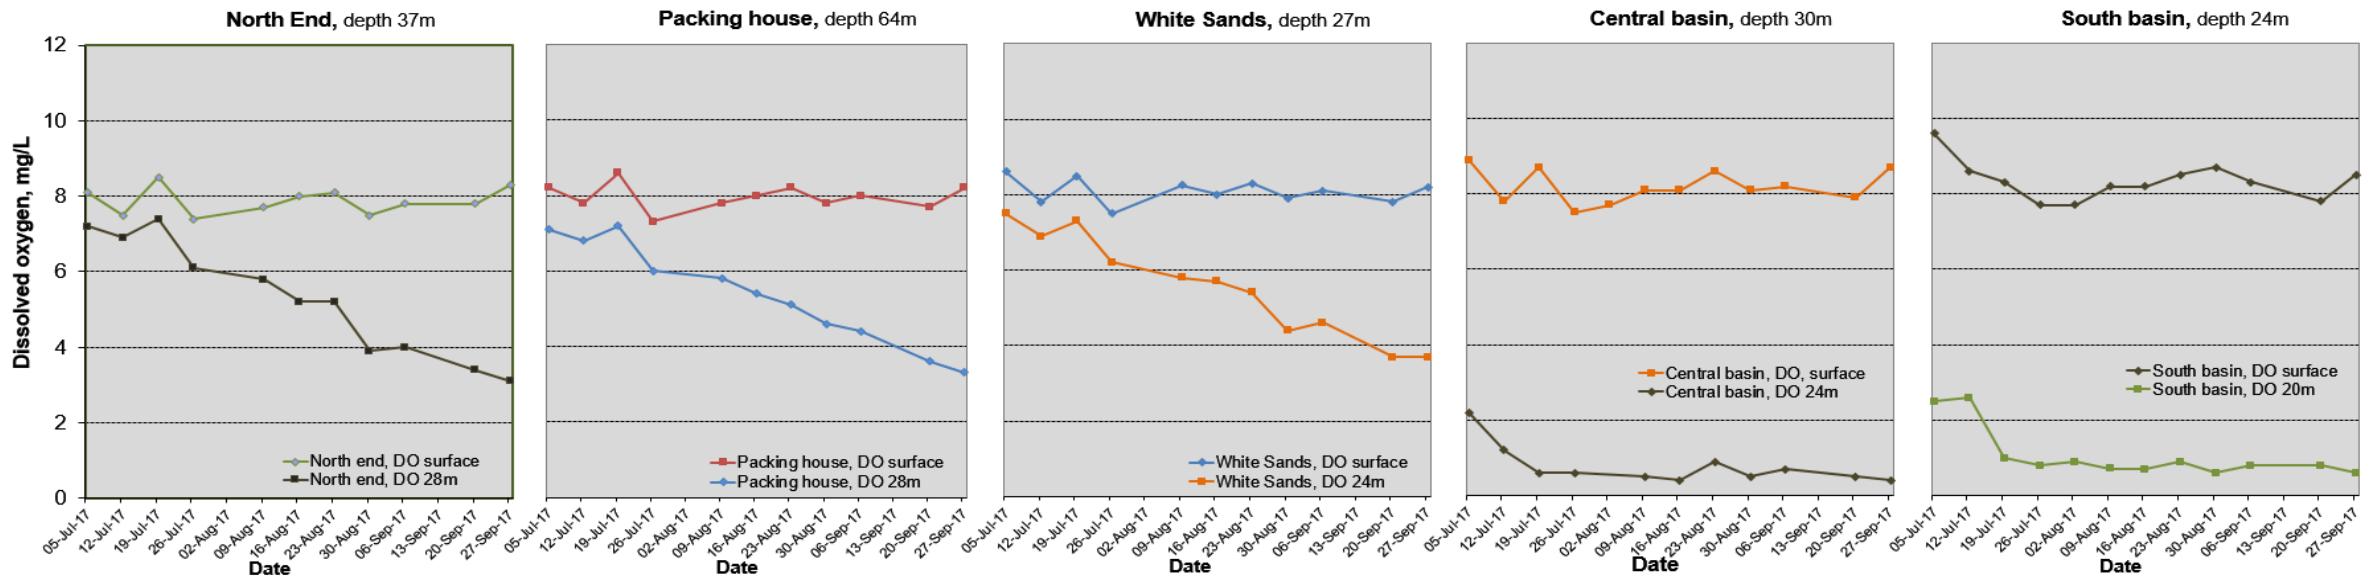
COMPARISON CHARTS 2017 - TOP AND BOTTOM DISSOLVED OXYGEN,
NORTH END TO SOUTH BASIN IN THE DIRECTION OF WATER FLOW.

OBJECTIVE VALUE: None.

OBSERVATION: A decline of bottom dissolved oxygen for the North basin locations, very low values for the Central and South basins.

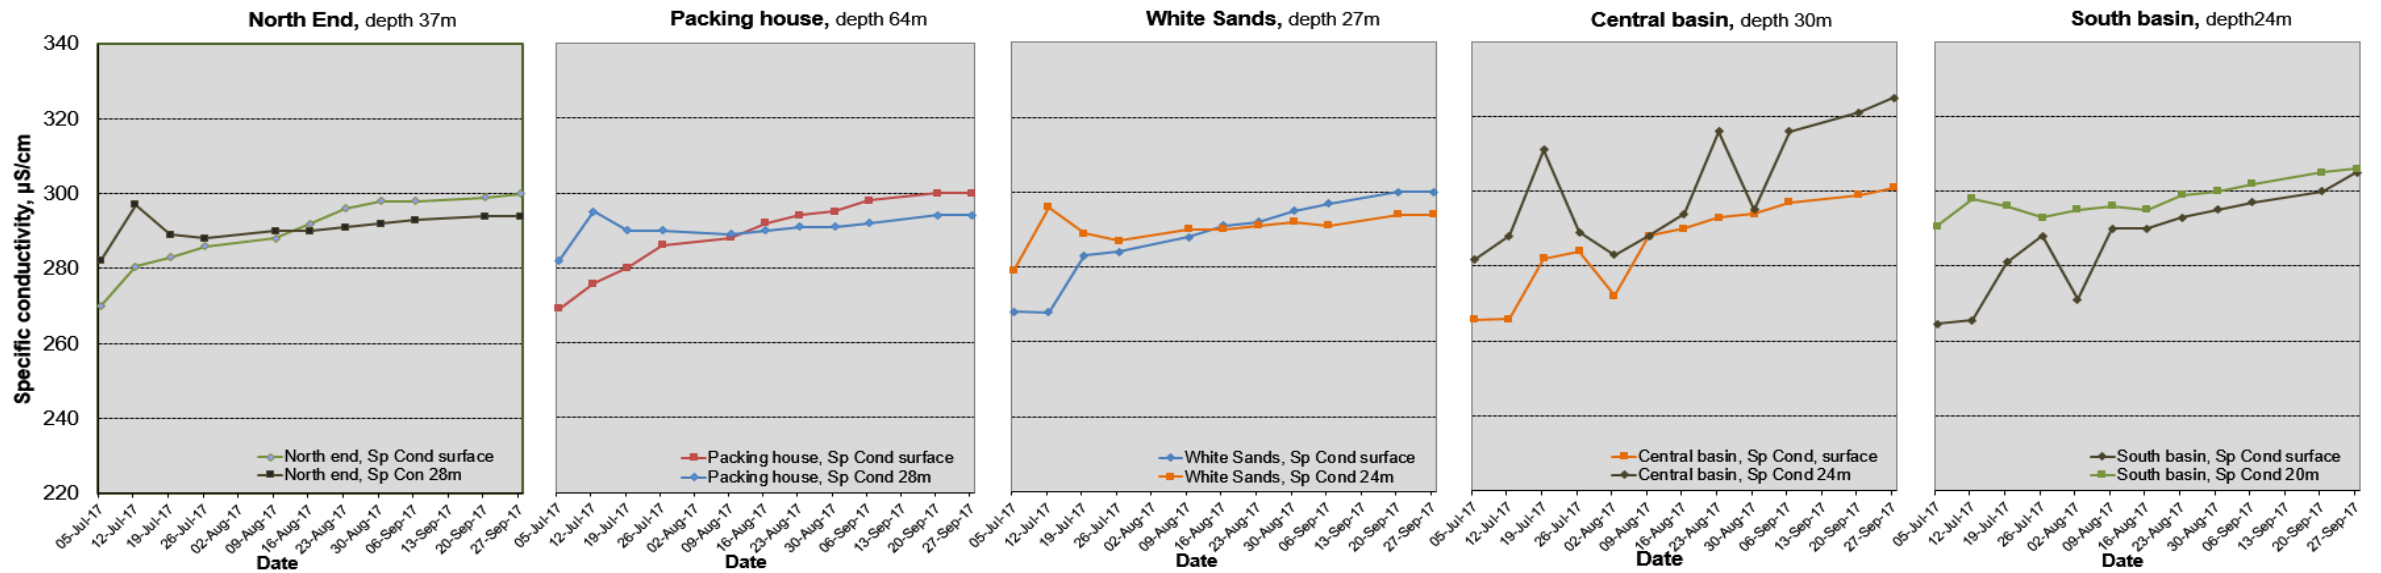
COMPARISON CHARTS 2017 - TOP AND BOTTOM SPECIFIC CONDUCTIVITY (25 C),
NORTH END TO SOUTH BASIN IN THE DIRECTION OF WATER FLOW.

OBJECTIVE VALUE: None.

OBSERVATION: A similar steady trending of Specific conductivity for the North basin locations, and cross-over mid-August.

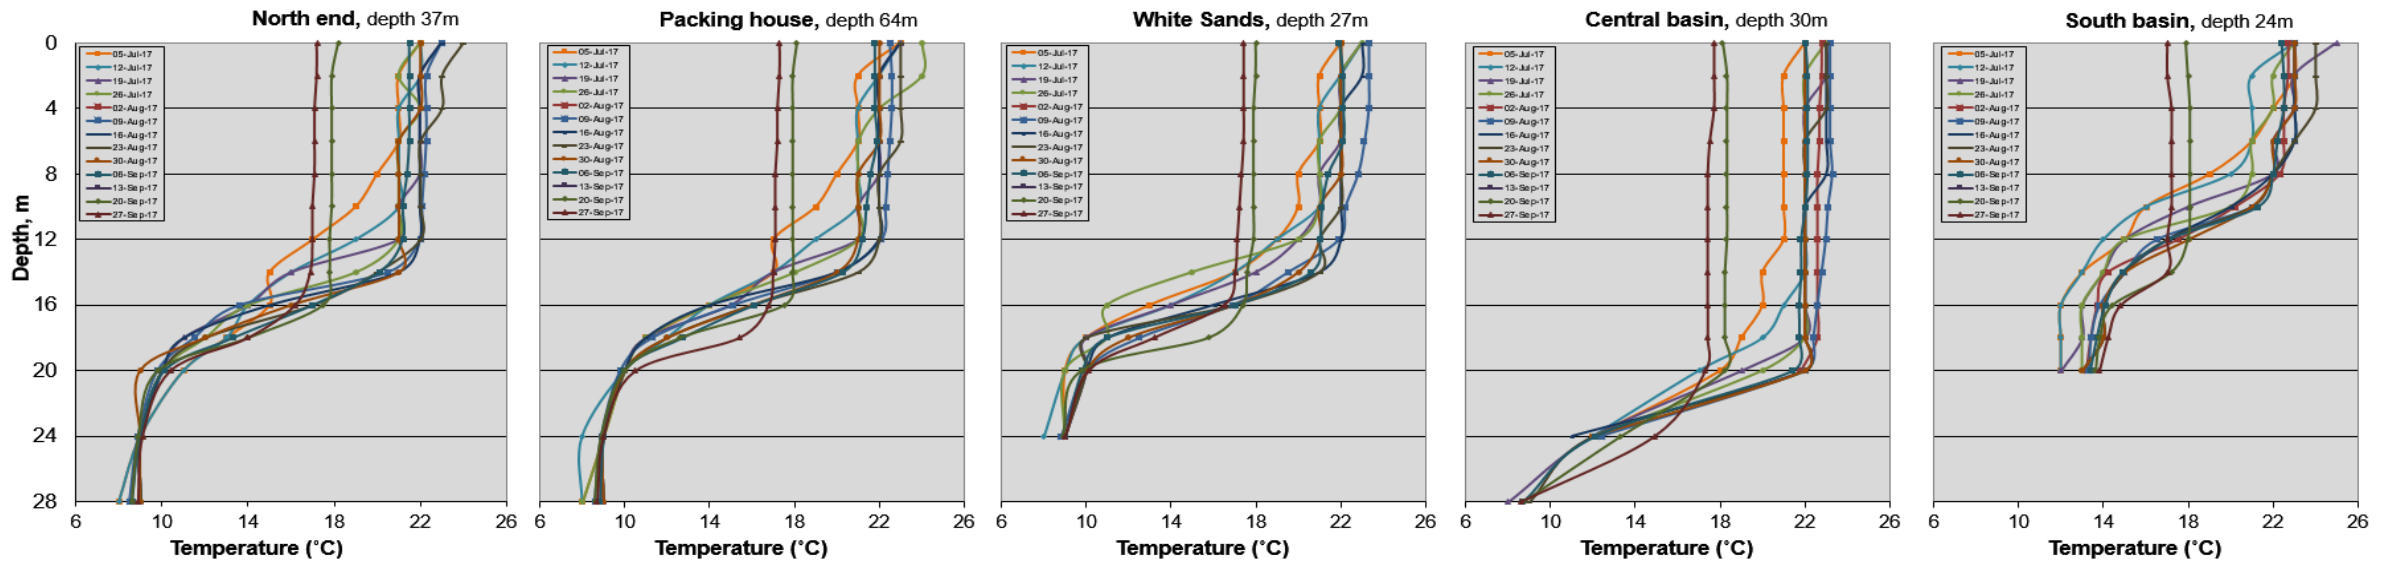
COMPARISON CHARTS 2017 - TEMPERATURE-DEPTH PROFILES, NORTH
END TO SOUTH BASIN IN THE DIRECTION OF WATER FLOW.

OBJECTIVE VALUE: None.

OBSERVATION: Thermoclines are seen at all locations over the testing season.

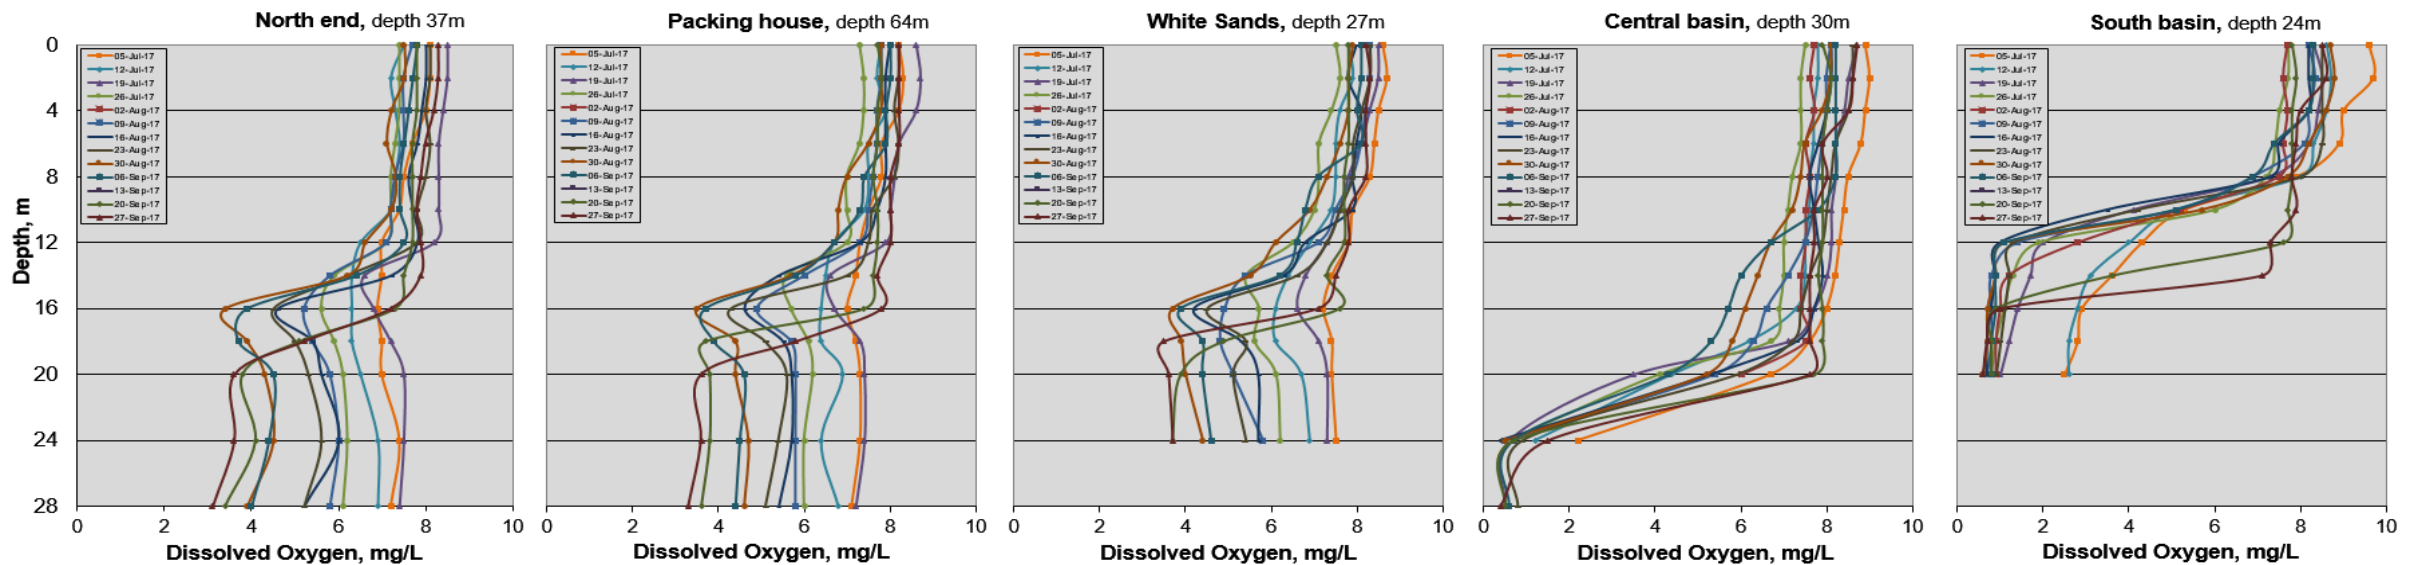
COMPARISON CHARTS 2017 - DISSOLVED OXYGEN-DEPTH PROFILES,
NORTH END TO SOUTH BASIN IN THE DIRECTION OF WATER FLOW.

OBJECTIVE VALUE: ≥ 5.8 mg/L at 15m on August 15th.

OBSERVATION: Objective, actual values – NE 5.9, PH 5.0, WS 5.2, CB 7.8, SB 0.9. Oxygen declines are seen at all locations. North basin locations, below 16m, show a spread of trends that move to lower values over the testing season.
